**Flood Control Project Maintenance
Levee Inspections**

Maintenance Issue Types Only, Levee Inspection Report By Mile - Spring 2018

Reclamation District No. 2060 Hastings

Waterway	Bank	Unit Miles	Inspection Start/End	Inspector
Unit No. 01 Lindsey Slough	Left	6.97	03/28/2018 03/28/2018	Keith Millard

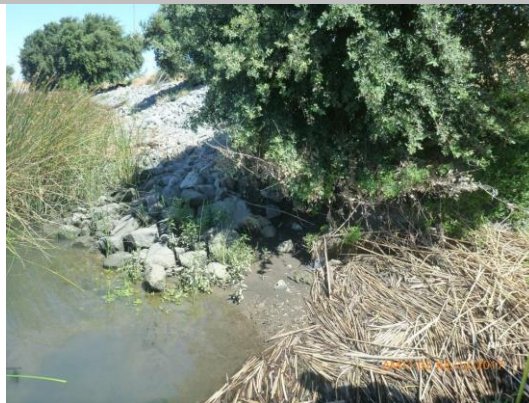
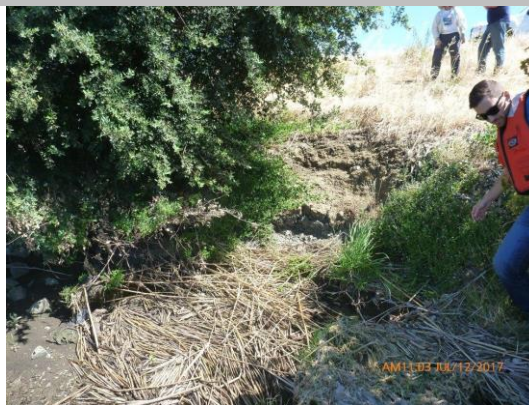
LM Start	0.41	Rating **	M	Issue No.	8 (cont)	
LM End	0.42	Issue Type +	Ma	Location *		
Category	Supplemental			GPS Latitude/Longitude		
				Start	End	
Item	2017 Storm Damage			38.248036 °	38.248017 °	
				-121.703539 °	-121.703789 °	
DWR ID	DWR_RD2060_01_f_2017_8					
Comment Code						
Inspector Comment						
Levee Evaluation Comments						
Description:Erosion commences approximately halfway down the water side slope extending in to existing rip rap. Existing rip rap appears to have been pulled off in this section.						
Site ID No:359						
Site Designation:LMA-186						
Repair Type: Erosion						
Rating:Area of Concern						
Field Date:7/12/2017						
Notes: Site had riprap but is eroded away. Minor erosion in toe of levee.

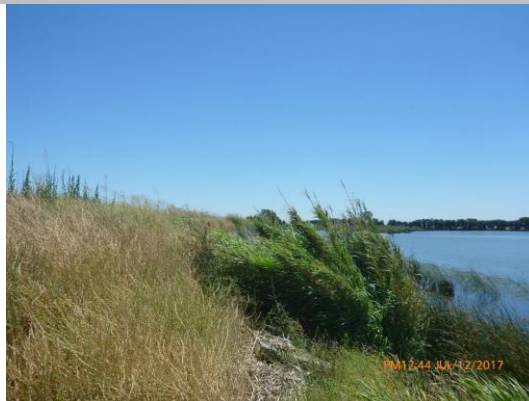
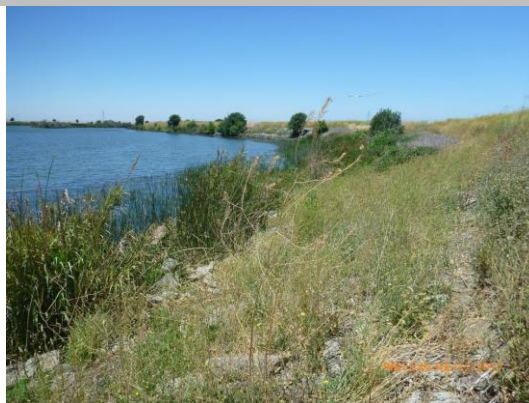
LM Start	0.92	Rating **	M	Issue No.	10
LM End	0.93	Issue Type +	Ma	Location *	
Category	Supplemental			GPS Latitude/Longitude	
				Start	End
Item	2017 Storm Damage			38.250875 °	38.250953 °
				-121.711942 °	-121.712078 °
DWR ID	DWR_RD2060_01_f_2017_10				
Comment Code					
Inspector Comment					
Levee Evaluation Comments Description:Sloughing commences approximately halfway down the water side slope. Site ID No:361 Site Designation:LMA-188 Repair Type: Erosion Rating:Area of Concern Field Date:7/12/2017 Notes: Minor sloughing, mostly riprap has moved down the slope and into channel.

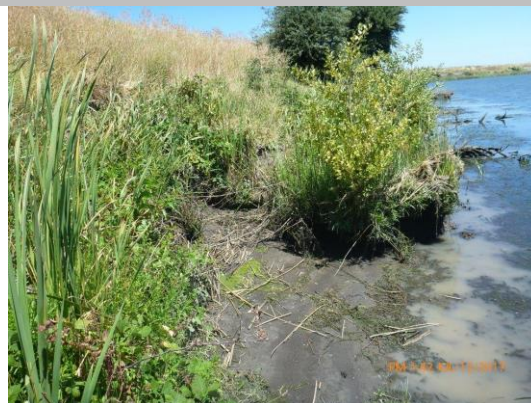
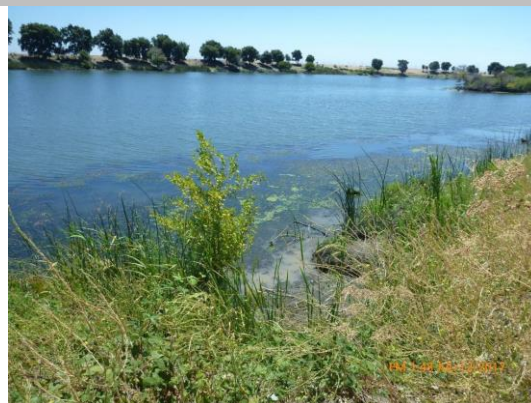
Notes: Small erosion up to high water line. Cuts into slope with 6' vertical cut.

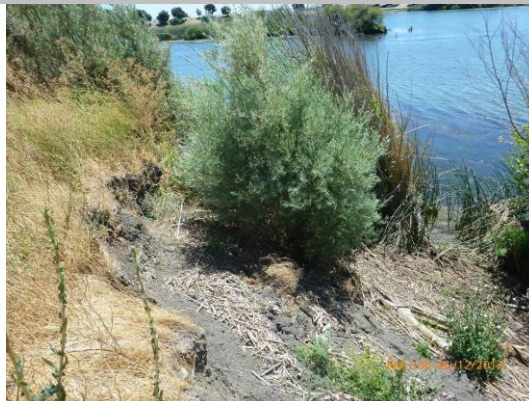
Photo 1 of 3 : SP_2018_RD2060_241_17_20180305_00023.jpg

LM Start	1.22	Rating **	A/W	Issue No.	17	
LM End	1.23	Issue Type +	Ma	Location *		
Category	Supplemental			GPS Latitude/Longitude		
				Start	End	
Item	2017 Storm Damage			38.251186 °	38.251289 °	
				-121.717114 °	-121.717264 °	
DWR ID	DWR_RD2060_01_f_2017_17					
Comment Code						
Inspector Comment						
Levee Evaluation Comments						
Description:Erosion commences approximately 1/4 of the way down the water side slope extending to the toe.						
Site ID No:364						
Site Designation:LMA-191						
Repair Type: Erosion						
Rating:Critical						
Field Date:7/12/2017						
Notes: Very deep erosion that extends halfway into slope. Intact riprap on both sdes of erosion. Rated serious but could be critical if erosion cuts deep into prism.

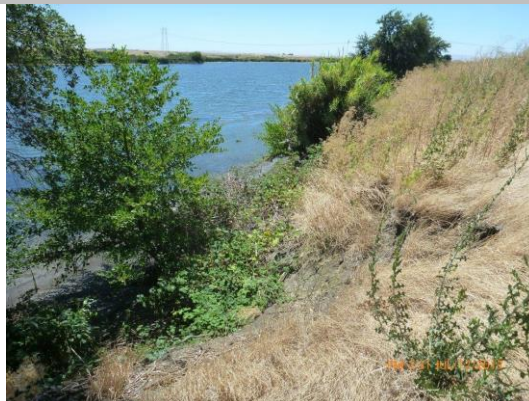
Photo 2 of 3 : SP_2018_RD2060_241_20_20180305_00027.jpg

LM Start	1.39	Rating **	A/W	Issue No.	20 (cont)
LM End	1.56	Issue Type +	Ma	Location *	
Category	Supplemental			GPS Latitude/Longitude	
				Start	End
Item	2017 Storm Damage			38.251886 °	38.252619 °
				-121.719933 °	-121.722842 °
DWR ID	DWR_RD2060_01_f_2017_20				
Comment Code					
Inspector Comment					
Levee Evaluation Comments					
Description:Erosion commences approximately halfway down the water side slope extending to the toe.					
Site ID No:365					
Site Designation:LMA-192					
Repair Type: Erosion					
Rating:Serious					
Field Date:7/12/2017					
Notes: Several deep narrow cuts into levee, but mostly minor erosion at highwater line.

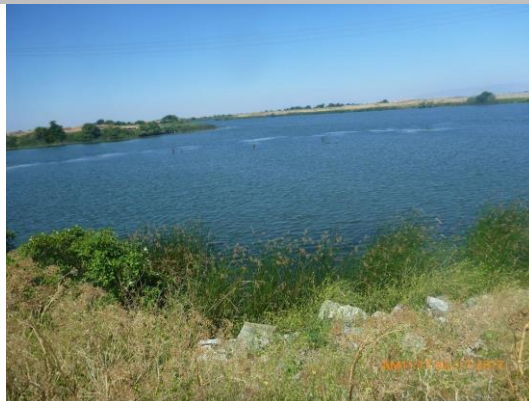
Photo 2 of 3 : SP_2018_RD2060_241_22_20180305_00033.jpg

Notes: Minor cracking observed below the hinge point and minor erosion at levee toe.

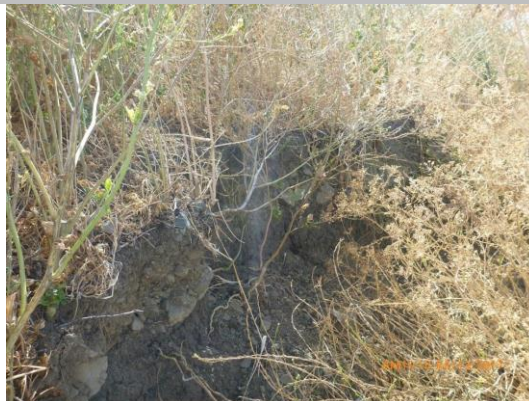
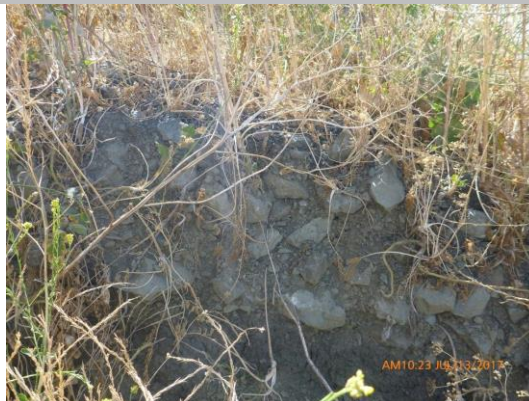
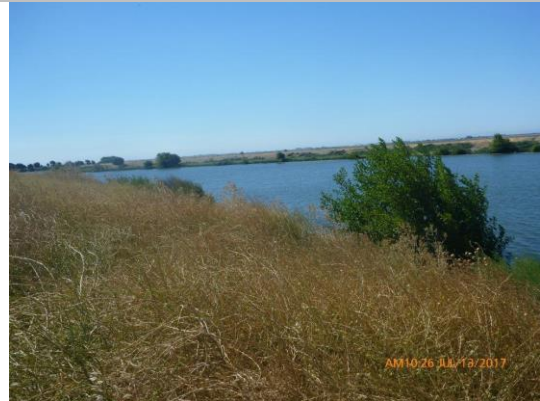
LM Start	2.10	Rating **	A/W	Issue No.	23
LM End	2.13	Issue Type +	Ma	Location *	
Category	Supplemental			GPS Latitude/Longitude	
				Start	End
Item	2017 Storm Damage			38.259317 °	38.259258 °
				-121.726314 °	-121.726939 °
DWR ID	DWR_RD2060_01_f _ 2017_23				
Comment Code					
Inspector Comment					
Levee Evaluation Comments					
Description:Erosion commences approximately halfway down the water side slope extending to the rip rap.					
Site ID No:368					
Site Designation:LMA-195					
Repair Type: Erosion					
Rating:Serious					
Field Date:7/13/2017					
Notes: Erosion appears to be previously repaired, but has failed again.

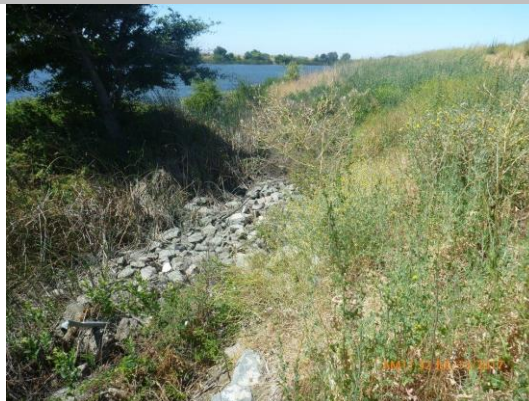
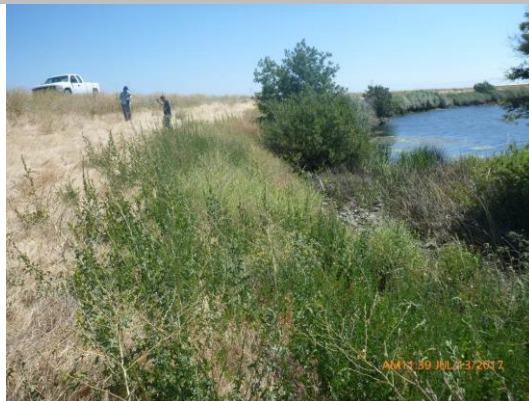
LM Start	3.07	Rating **	A/W	Issue No.	25
LM End	3.10	Issue Type +	Ma	Location *	
Category	Supplemental			GPS Latitude/Longitude	
				Start	End
Item	2017 Storm Damage			38.260772 °	38.260569 °
				-121.740817 °	-121.741194 °
DWR ID	DWR_RD2060_01_f_2017_25				
Comment Code					
Inspector Comment					
Levee Evaluation Comments					
Description:Erosion occurs near the waterline. Part of the levee has sloughed down toward the waterline due to erosion.					
Site ID No:370					
Site Designation:LMA-197					
Repair Type: Erosion					
Rating:Serious					
Field Date:7/13/2017					
Notes: Large erosion halfway into levee. Horizontal cracking on slope almost 24"deep.

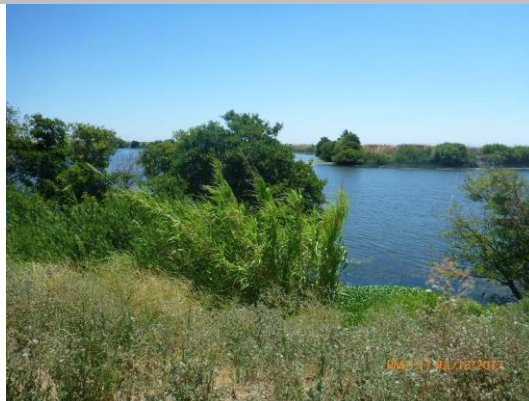
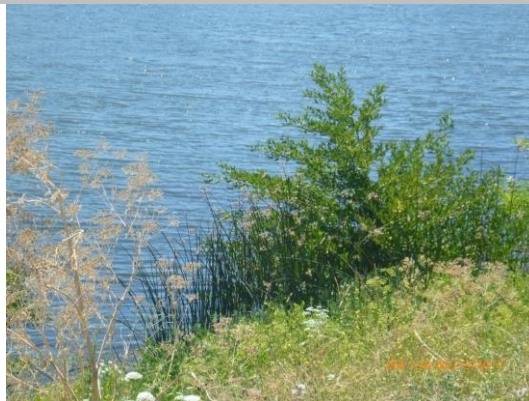
LM Start	3.60	Rating **	M	Issue No.	27
LM End	3.61	Issue Type +	Ma	Location *	
Category	Supplemental			GPS Latitude/Longitude	
				Start	End
Item	2017 Storm Damage			38.261469 °	38.261464 °
				-121.748389 °	-121.748442 °
DWR ID	DWR_RD2060_01_f_2017_27				
Comment Code					
Inspector Comment					
Levee Evaluation Comments					
Description:Erosion commences halfway down the slope and extends to the toe. Erosion is concentrated at the water line.					
Site ID No:373					
Site Designation:LMA-200					
Repair Type: Erosion					
Rating:Area of Concern					
Field Date:7/13/2017					
Notes: Small erosion with a narrow deep cut. Heavy veg is protecting the slope.

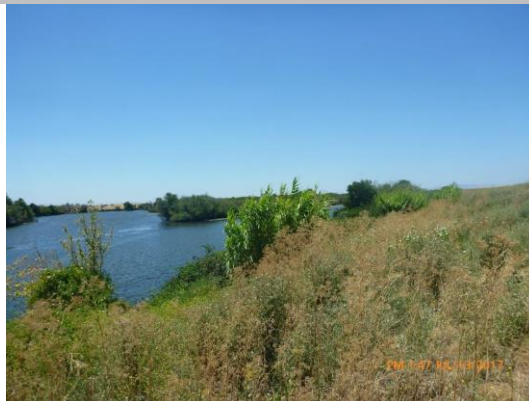
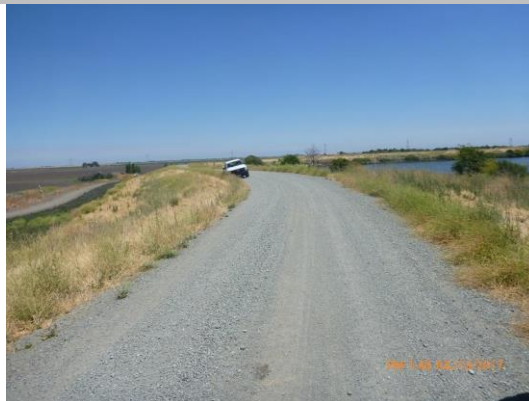
LM Start	3.67	Rating **	M	Issue No.	28 (cont)
LM End	3.67	Issue Type +	Ma	Location *	
Category	Supplemental			GPS Latitude/Longitude	
				Start	End
Item	2017 Storm Damage			38.261181 °	38.261167 °
				-121.749542 °	-121.749592 °
DWR ID	DWR_RD2060_01_f_2017_28				
Comment Code					
Inspector Comment					
Levee Evaluation Comments					
Description:Erosion is concentrated near the water line.					
Site ID No:374					
Site Designation:LMA-201					
Repair Type: Erosion					
Rating:Area of Concern					
Field Date:7/13/2017					
Notes: Small narrow and deep cut. May have been caused by a collapsed beaver den.

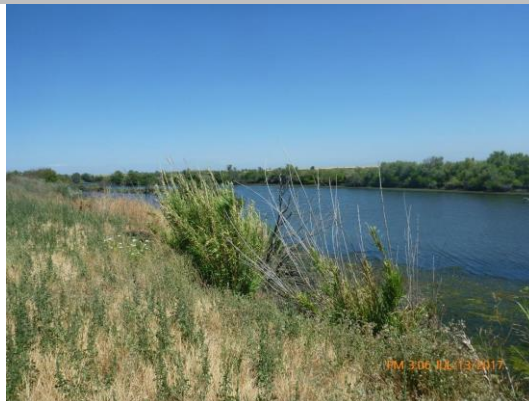
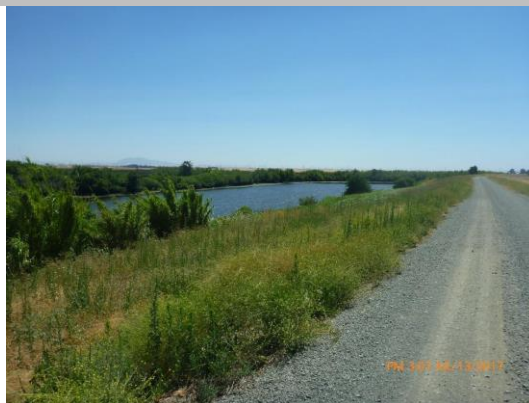
LM Start	4.40	Rating **	M	Issue No.	30 (cont)	
LM End	4.46	Issue Type +	Ma	Location *		
Category	Supplemental			GPS Latitude/Longitude		
				Start	End	
Item	2017 Storm Damage			38.260850 °	38.260425 °	
				-121.761875 °	-121.762861 °	
DWR ID	DWR_RD2060_01_f_2017_30					
Comment Code						
Inspector Comment						
Levee Evaluation Comments						
Description:Erosion/sloughing commences approximately halfway down the slope. Erosion is concentrated mostly near the water line and has resulting in slippage of the slope.						
Site ID No:377						
Site Designation:LMA-204						
Repair Type: Erosion						
Rating:Area of Concern						
Field Date:7/13/2017						
Notes: large cut is 100' of 320' site. Large cut is 12' vertical and the rest is 6'.

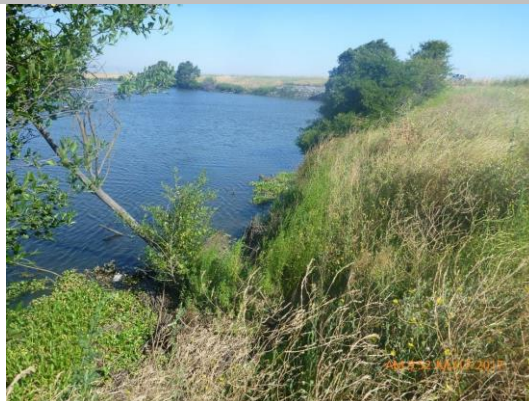
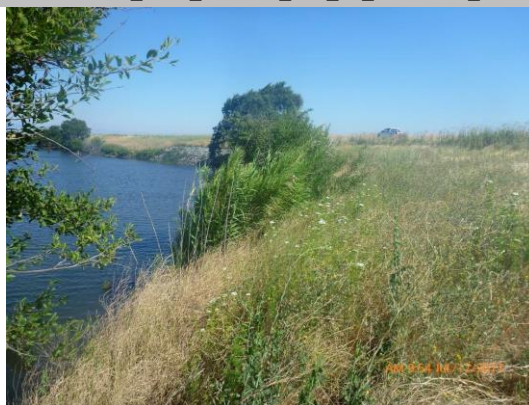
LM Start	4.80	Rating **	A/W	Issue No.	32 (cont)
LM End	4.88	Issue Type +	Ma	Location *	
Category	Supplemental			GPS Latitude/Longitude	
				Start	End
Item	2017 Storm Damage			38.260714 °	38.261808 °
				-121.767972 °	-121.768536 °
DWR ID	DWR_RD2060_01_f_2017_32				
Comment Code					
Inspector Comment					
Levee Evaluation Comments					
Description:Erosion/sloughing commences approximately halfway down the slope. Erosion is concentrated mostly near the water line and has resulting in slippage of the slope towards the toe.					
Site ID No:379					
Site Designation:LMA-206					
Repair Type: Erosion					
Rating:Serious					
Field Date:7/17/2017					
Notes: Several erosions with slumping. Fresh soil indicates active erosion this season. Adjacent slope has riprap. Riprap should be extended along this stretch.

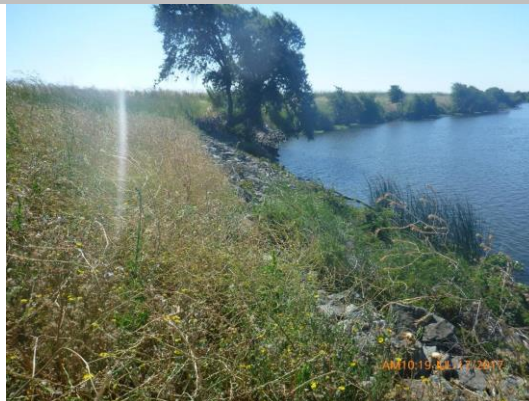
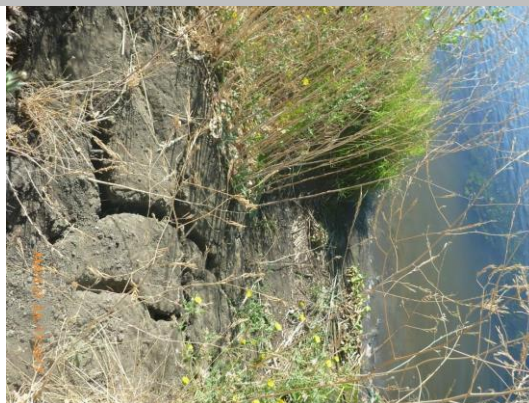
LM Start	4.92	Rating **	M	Issue No.	33
LM End	4.92	Issue Type +	Ma	Location *	
Category	Supplemental			GPS Latitude/Longitude	
				Start	End
Item	2017 Storm Damage			38.262128 °	38.262128 °
				-121.769175 °	-121.769175 °
DWR ID	DWR_RD2060_01_f_2017_33				
Comment Code					
Inspector Comment					
Levee Evaluation Comments					
Description:Erosion/sloughing commences approximately halfway down the slope. Erosion is concentrated mostly near the water line and has resulting in slippage of the slope into the toe.					
Site ID No:380					
Site Designation:LMA-207					
Repair Type: Erosion					
Rating:Area of Concern					
Field Date:7/17/2017					
Notes: Reduced length of site from 275 to 62. No widespread erosion, just 2 small erosions upstream from adjacent riprap.

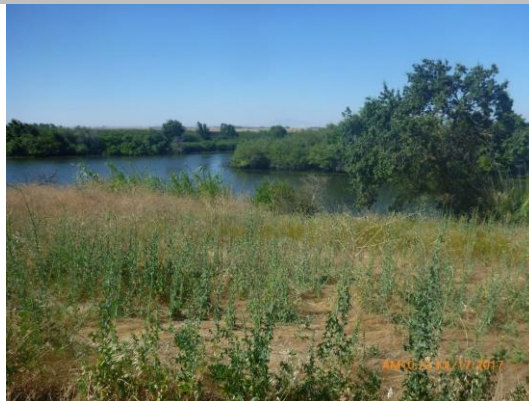
Photo 3 of 3 : SP_2018_RD2060_241_33_20180305_00067.jpg

LM Start	4.92	Rating **	M	Issue No.	33 (cont)	
LM End	4.92	Issue Type +	Ma	Location *		
Category	Supplemental			GPS Latitude/Longitude		
				Start	End	
Item	2017 Storm Damage			38.262128 °	38.262128 °	
				-121.769175 °	-121.769175 °	
DWR ID	DWR_RD2060_01_f_2017_33					
Comment Code						
Inspector Comment						
Levee Evaluation Comments						
Description:Erosion/sloughing commences approximately halfway down the slope. Erosion is concentrated mostly near the water line and has resulting in slippage of the slope into the toe.						
Site ID No:380						
Site Designation:LMA-207						
Repair Type: Erosion						
Rating:Area of Concern						
Field Date:7/17/2017						
Notes: Reduced length of site from 275 to 62. No widespread erosion, just 2 small erosions upstream from adjacent riprap.

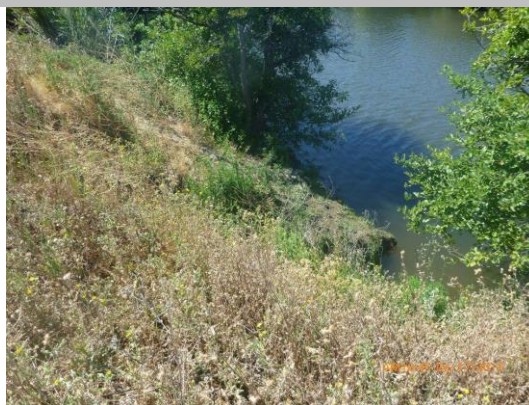
Photo 1 of 3 : SP_2018_RD2060_241_34_20180305_00068.jpg

LM Start	5.00	Rating **	M	Issue No.	34
LM End	5.01	Issue Type +	Ma	Location *	
Category	Supplemental			GPS Latitude/Longitude	
				Start	End
Item	2017 Storm Damage			38.262636 °	38.262658 °
				-121.770503 °	-121.770547 °
DWR ID	DWR_RD2060_01_f_2017_34				
Comment Code					
Inspector Comment					
Levee Evaluation Comments					
Description:Erosion is concentrated mostly near the water line and has resulting in slippage of the slope into the toe.					
Site ID No:381					
Site Designation:LMA-208					
Repair Type: Erosion					
Rating:Area of Concern					
Field Date:7/17/2017					
Notes: Extended site from 15' to 75' to include LMA-209. Small erosions will become 1 site next high water due to sloughing between them.

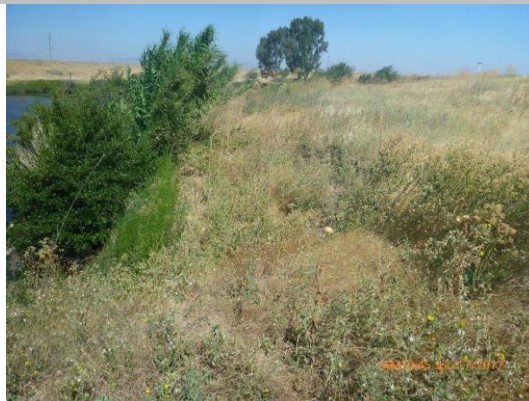
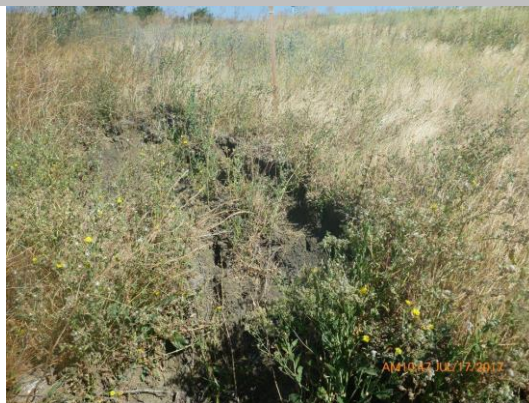
LM Start	5.00	Rating **	M	Issue No.	34 (cont)
LM End	5.01	Issue Type +	Ma	Location *	
Category	Supplemental			GPS Latitude/Longitude	
				Start	End
Item	2017 Storm Damage			38.262636 °	38.262658 °
				-121.770503 °	-121.770547 °
DWR ID	DWR_RD2060_01_f_2017_34				
Comment Code					
Inspector Comment					
Levee Evaluation Comments					
Description:Erosion is concentrated mostly near the water line and has resulting in slippage of the slope into the toe.					
Site ID No:381					
Site Designation:LMA-208					
Repair Type: Erosion					
Rating:Area of Concern					
Field Date:7/17/2017					
Notes: Extended site from 15' to 75' to include LMA-209. Small erosions will become 1 site next high water due to sloughing between them.

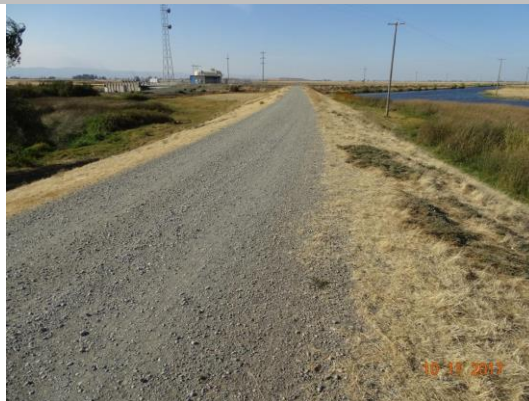
Photo 1 of 1 : SP_2018_RD2060_242_5_20180305_00001.jpg

LM Start	0.12	Rating **	A/W	Issue No.	5
LM End	0.12	Issue Type +	Ma	Location *	LS
Category	Earthen Levee			GPS Latitude/Longitude	
				Start	End
Item	Vegetation			38.276399 °	38.276399 °
				-121.795927 °	-121.795927 °
DWR ID	DWR_RD2060_02_f_2017_5				
Comment Code					
V2 : Remove the wild growth other than native grasses from the levee slopes.					
Inspector Comment

Landside vegetation is acceptable at LM 0.12.

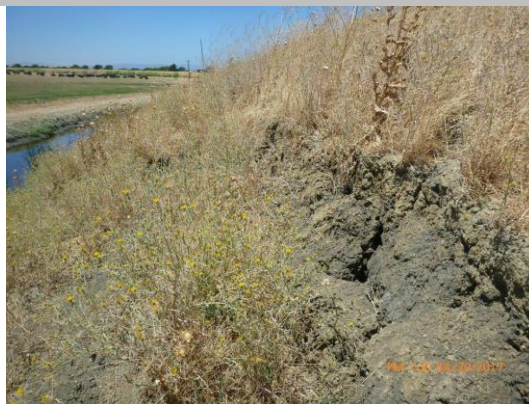
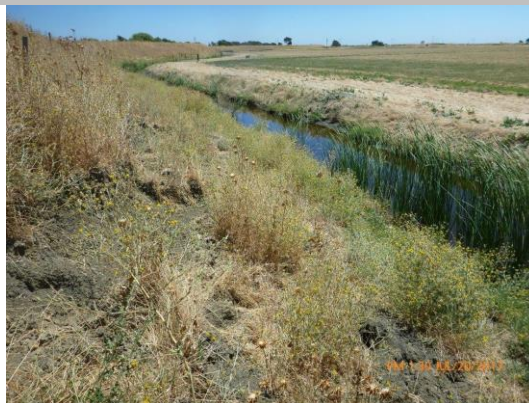
LM Start	0.12	Rating **	M	Issue No.	13
LM End	0.18	Issue Type +	Ma	Location *	
Category	Supplemental			GPS Latitude/Longitude	
				Start	End
Item	2017 Storm Damage			38.295919 °	38.295611 °
				-121.746700 °	-121.745742 °
DWR ID	DWR_RD2060_03_f _ 2017_13				
Comment Code					
Inspector Comment					
Levee Evaluation Comments					
Description:Sloughing and seepage occurs near the land side toe.					
Site ID No:385					
Site Designation:LMA-212					
Repair Type: Stability					
Rating:Area of Concern					
Field Date:7/20/2017					
Notes: Moderate sloughing halfway down LS slope. Monitor for progression.

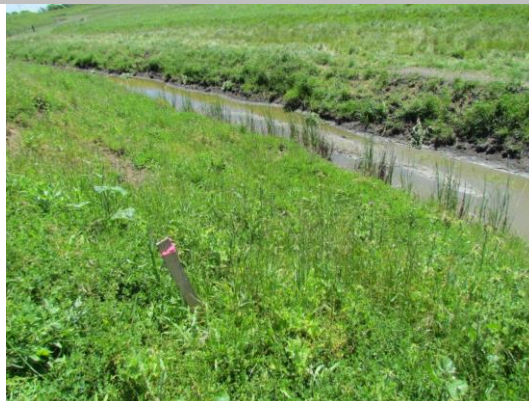
Photo 2 of 2 : SP_2018_RD2060_243_19_20180305_00024.jpg

LM Start	0.15	Rating **	A/W	Issue No.	19 (cont)
LM End	0.19	Issue Type +	Ma	Location *	LS
Category	Earthen Levee			GPS Latitude/Longitude	
				Start	End
Item	Slope Stability			38.295738 °	38.295559 °
				-121.746293 °	-121.745583 °
DWR ID	DWR_RD2060_03_s_2017_19				
Comment Code					
S1 : Repair slope instability.					
Inspector Comment					
There are several signs of sloughing occurring on the slope notices after the flood event Feb. 2017 storm. 10/11/17: This issue's rating has been changed from U to A/W in consideration of the DWR 2017 Levee Evaluation Storm Site entry.

Just upstream of the erosion site looking downstream from the landside slope.

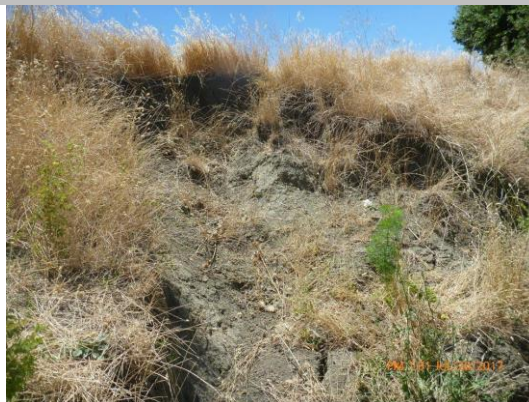
Photo 1 of 3 : SP_2018_RD2060_243_14_20180305_00013.jpg

LM Start	0.64	Rating **	M	Issue No.	14
LM End	0.64	Issue Type +	Ma	Location *	
Category	Supplemental			GPS Latitude/Longitude	
				Start	End
Item	2017 Storm Damage			38.292197 °	38.292208 °
				-121.739661 °	-121.739611 °
DWR ID	DWR_RD2060_03_f_2017_14				
Comment Code					
Inspector Comment					
Levee Evaluation Comments					
Description:Erosion commences near the edge of the crown and extends down the slope. Erosion has resulted in slippage into the waterside toe.					
Site ID No:386					
Site Designation:LMA-213					
Repair Type: Erosion					
Rating:Area of Concern					
Field Date:7/20/2017					
Notes:

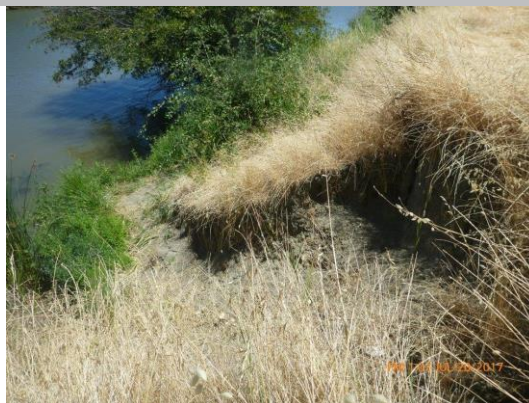
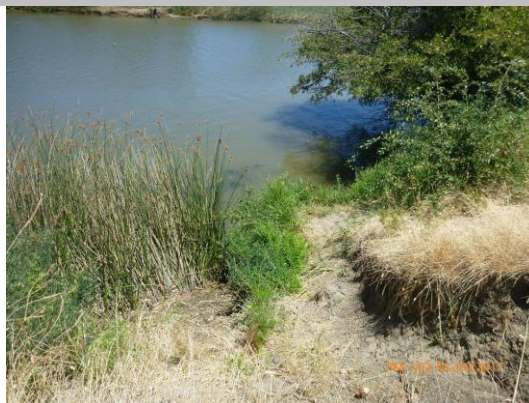
LM Start	0.64	Rating **	M	Issue No.	14 (cont)
LM End	0.64	Issue Type +	Ma	Location *	
Category	Supplemental			GPS Latitude/Longitude	
				Start	End
Item	2017 Storm Damage			38.292197 °	38.292208 °
				-121.739661 °	-121.739611 °
DWR ID	DWR_RD2060_03_f_2017_14				
Comment Code					
Inspector Comment					
Levee Evaluation Comments					
Description:Erosion commences near the edge of the crown and extends down the slope. Erosion has resulted in slippage into the waterside toe.					
Site ID No:386					
Site Designation:LMA-213					
Repair Type: Erosion					
Rating:Area of Concern					
Field Date:7/20/2017					
Notes:

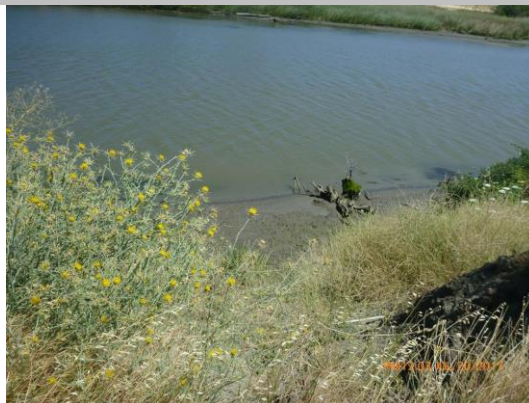
Photo 1 of 3 : SP_2018_RD2060_243_17_20180305_00018.jpg

LM Start	1.12	Rating **	A/W	Issue No.	17
LM End	1.13	Issue Type +	Ma	Location *	
Category	Supplemental			GPS Latitude/Longitude	
				Start	End
Item	2017 Storm Damage			38.290539 °	38.290544 °
				-121.731603 °	-121.731494 °
DWR ID	DWR_RD2060_03_f_2017_17				
Comment Code					
Inspector Comment					
Levee Evaluation Comments					
Description:Erosion commences near the crown and has resulted in slippage into the waterside toe.					
Site ID No:389					
Site Designation:LMA-216					
Repair Type: Erosion					
Rating:Critical					
Field Date:7/20/2017					
Notes: Vertical section sloughing halfway down WS slope. Continued erosion down WS slope. Recommemd repair before next high water.

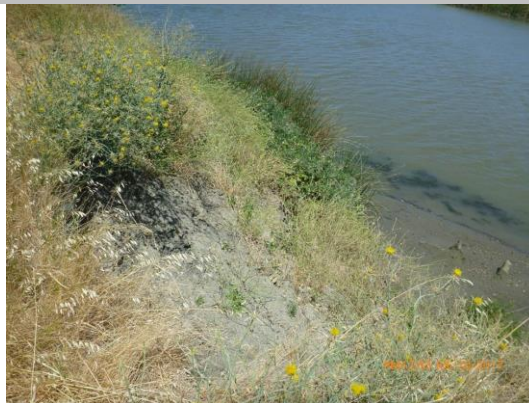
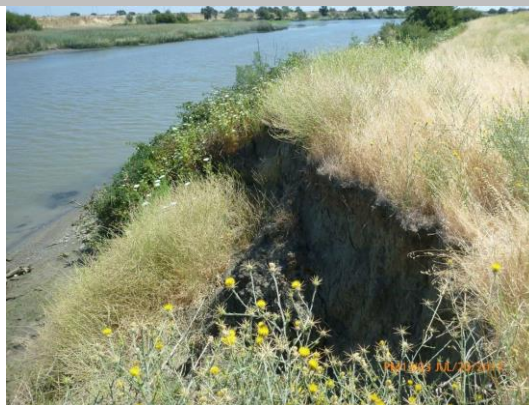
Notes: Vertical section sloughing halfway down WS slope. Continued erosion down WS slope. Recommend repair before next high water.

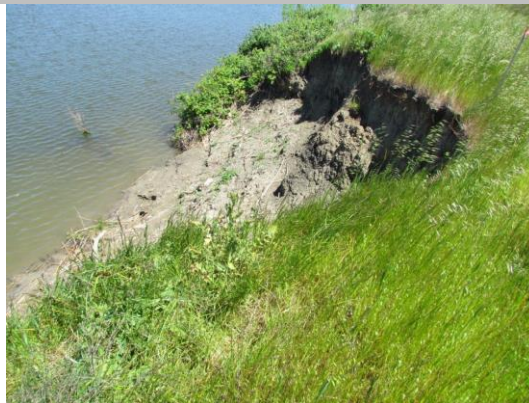
Photo 1 of 2 : SP_2018_RD2060_243_18_20180305_00021.jpg

LM Start	1.12	Rating **	A/W	Issue No.	18
LM End	1.12	Issue Type +	Ma	Location *	WS
Category	Earthen Levee			GPS Latitude/Longitude	
				Start	End
Item	Slope Stability			38.290558 °	38.290558 °
				-121.731580 °	-121.731580 °
DWR ID	DWR_RD2060_03_s_2017_18				
Comment Code					
S1 : Repair slope instability.					
Inspector Comment					
The District has scheduled repairs of this site. 10/11/17: This issue's rating has been changed from U to A/W in consideration of the DWR 2017 Levee Evaluation Storm Site entry.

Looking downstream at the erosion in the waterside slope and toe.

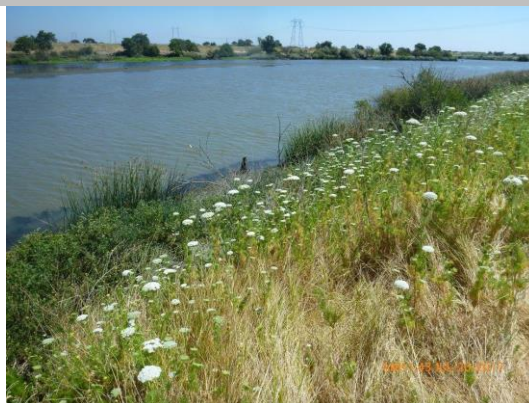
Photo 3 of 3 : SP_2018_RD2060_243_20_20180305_00027.jpg

LM Start	1.21	Rating **	M	Issue No.	20 (cont)	
LM End	1.23	Issue Type +	Ma	Location *		
Category	Supplemental			GPS Latitude/Longitude		
				Start		End
Item	2017 Storm Damage			38.290511 °		38.290486 °
				-121.729867 °		-121.729603 °
DWR ID	DWR_RD2060_03_f_2017_20					
Comment Code						
Inspector Comment						
Levee Evaluation Comments						
Description:Erosion commences 1/4 of the way down the slope with						
slippage towards the water side toe.						
Site ID No:390						
Site Designation:LMA-217						
Repair Type: Erosion						
Rating:Area of Concern						
Field Date:7/20/2017						
Notes: Erosion halfway down WS slope. Monitor for progression.

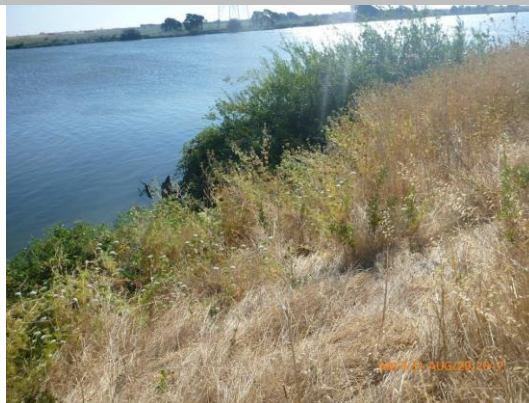
Photo 1 of 3 : SP_2018_RD2060_243_21_20180305_00028.jpg

LM Start	1.38	Rating **	M	Issue No.	21
LM End	1.42	Issue Type +	Ma	Location *	
Category	Supplemental			GPS Latitude/Longitude	
				Start	End
Item	2017 Storm Damage			38.290067 °	38.289608 °
				-121.726839 °	-121.726344 °
DWR ID	DWR_RD2060_03_f_2017_21				
Comment Code					
Inspector Comment					
Levee Evaluation Comments Description:MBK Delta Erosion Sites_6-29-2017 Site ID No:482 Site Designation:LMA-320 Repair Type: Erosion Rating:Area of Concern Field Date:8/29/2017 Notes:

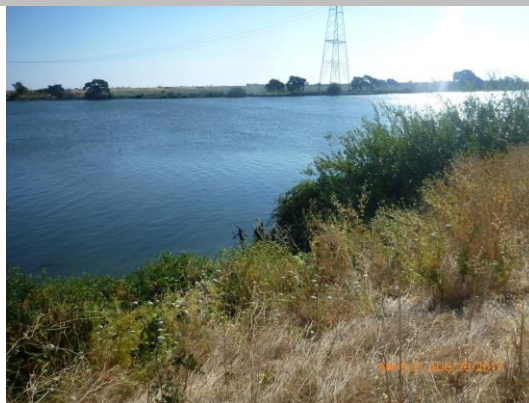
Photo 2 of 3 : SP_2018_RD2060_243_21_20180305_00029.jpg

LM Start	1.38	Rating **	M	Issue No.	21 (cont)	
LM End	1.42	Issue Type +	Ma	Location *		
Category	Supplemental			GPS Latitude/Longitude		
				Start	End	
Item	2017 Storm Damage			38.290067 °	38.289608 °	
				-121.726839 °	-121.726344 °	
DWR ID	DWR_RD2060_03_f_2017_21					
Comment Code						
Inspector Comment						
Levee Evaluation Comments						
Description:MBK Delta Erosion Sites_6-29-2017						
Site ID No:482						
Site Designation:LMA-320						
Repair Type: Erosion						
Rating:Area of Concern						
Field Date:8/29/2017						
Notes:

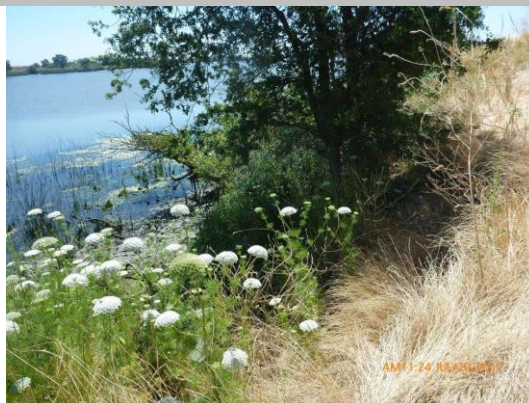
Photo 3 of 3 : SP_2018_RD2060_243_22_20180305_00033.jpg

LM Start	1.45	Rating **	M	Issue No.	22 (cont)	
LM End	1.59	Issue Type +	Ma	Location *		
Category	Supplemental			GPS Latitude/Longitude		
				Start	End	
Item	2017 Storm Damage			38.289256 °	38.287689 °	
				-121.726050 °	-121.724658 °	
DWR ID	DWR_RD2060_03_f _ 2017_22					
Comment Code						
Inspector Comment						
Levee Evaluation Comments						
Description:Erosion commences halfway down the slope and results in						
slippage into the waterside toe.						
Site ID No:392						
Site Designation:LMA-219						
Repair Type: Erosion						
Rating:Area of Concern						
Field Date:7/20/2017						
Notes: Moderate erosion present on WS slope. Monitor for progression.

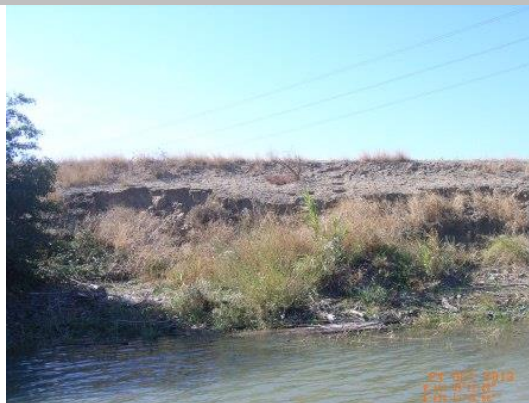
Photo 1 of 1 : SP_2018_RD2060_243_8_20180305_00008.jpg

LM Start	1.52	Rating **	A/W	Issue No.	8
LM End	1.74	Issue Type +	Ma	Location *	WS
Category	Supplemental			GPS Latitude/Longitude	
				Start	End
Item	2015 USACE Erosion Survey, DRAFT			38.288598 °	38.286051 °
				-121.725184 °	-121.722818 °
DWR ID	DWR_RD2060_03_s_2016_8				
Comment Code					
Inspector Comment					
Site added in 1997 and removed in 2003. 2005 - Put back in the inventory. 2006 - Stone repair at the middle of the site. 2011 - Some rock place at toe in the past year. 2013 - Site extended both upstream and downstream to include new erosion pockets. 2015: No observed changes. [2015 Site ID: CHS_23-6_R]

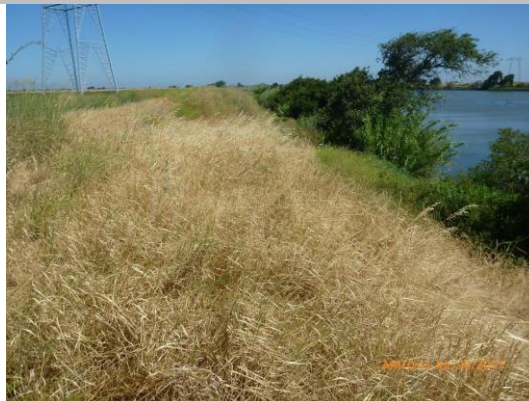
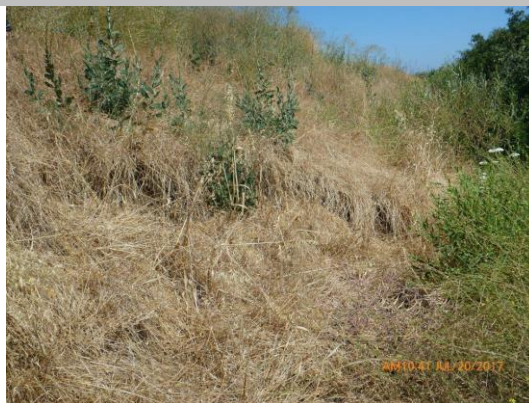
LM Start	1.62	Rating **	A/W	Issue No.	23
LM End	1.63	Issue Type +	Ma	Location *	
Category	Supplemental			GPS Latitude/Longitude	
				Start	End
Item	2017 Storm Damage			38.287336 °	38.287222 °
				-121.724364 °	-121.724253 °
DWR ID	DWR_RD2060_03_f_2017_23				
Comment Code					
Inspector Comment					
Levee Evaluation Comments					
Description:Erosion commences halfway down the slope and results in slippage into the waterside toe. Existing rip rap has sloughed into the water side toe.					
Site ID No:393					
Site Designation:LMA-220					
Repair Type: Erosion					
Rating:Serious					
Field Date:7/20/2017					
Notes: Moderate sloughing 8ft from WS crown. Erosion at high water mark.

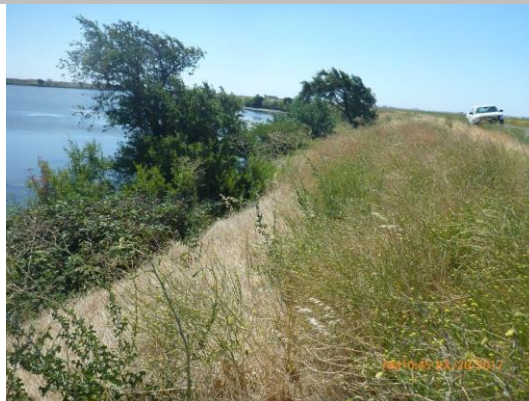
Photo 3 of 3 : SP_2018_RD2060_243_23_20180305_00036.jpg

LM Start	1.62	Rating **	A/W	Issue No.	23 (cont)	
LM End	1.63	Issue Type +	Ma	Location *		
Category	Supplemental			GPS Latitude/Longitude		
				Start	End	
Item	2017 Storm Damage			38.287336 °	38.287222 °	
				-121.724364 °	-121.724253 °	
DWR ID	DWR_RD2060_03_f_2017_23					
Comment Code						
Inspector Comment						
Levee Evaluation Comments						
Description:Erosion commences halfway down the slope and results in slippage into the waterside toe. Existing rip rap has sloughed into the water side toe.						
Site ID No:393						
Site Designation:LMA-220						
Repair Type: Erosion						
Rating:Serious						
Field Date:7/20/2017						
Notes: Moderate sloughing 8ft from WS crown. Erosion at high water mark.

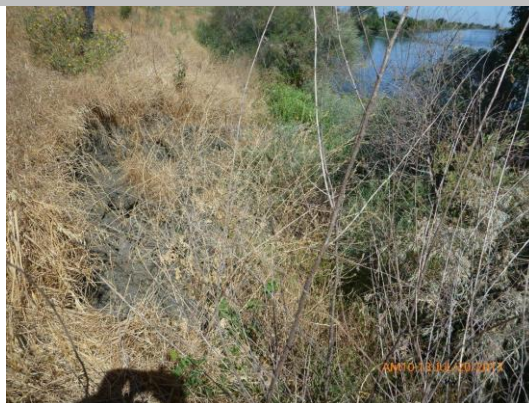
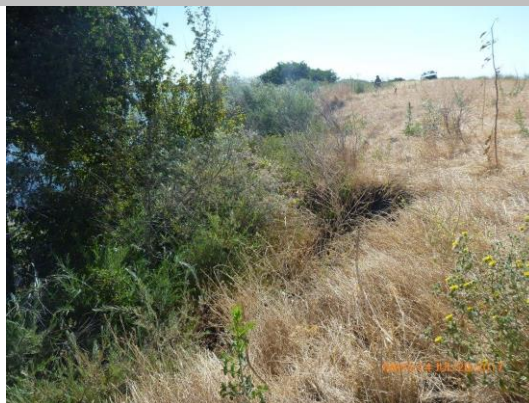
LM Start	1.84	Rating **	M	Issue No.	25 (cont)	
LM End	1.92	Issue Type +	Ma	Location *		
Category	Supplemental			GPS Latitude/Longitude		
				Start	End	
Item	2017 Storm Damage			38.284825 °	38.284467 °	
				-121.721764 °	-121.720339 °	
DWR ID	DWR_RD2060_03_f _ 2017_25					
Comment Code						
Inspector Comment						
Levee Evaluation Comments						
Description:Erosion commences halfway down the slope and results in						
slippage into the waterside toe.						
Site ID No:395						
Site Designation:LMA-222						
Repair Type: Erosion						
Rating:Area of Concern						
Field Date:7/20/2017						
Notes: Erosion halfway down slope. Monitor for progression.

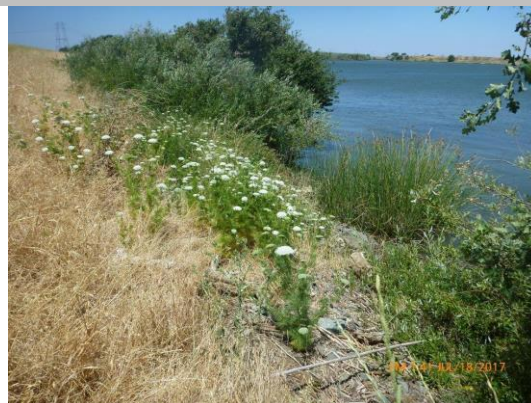
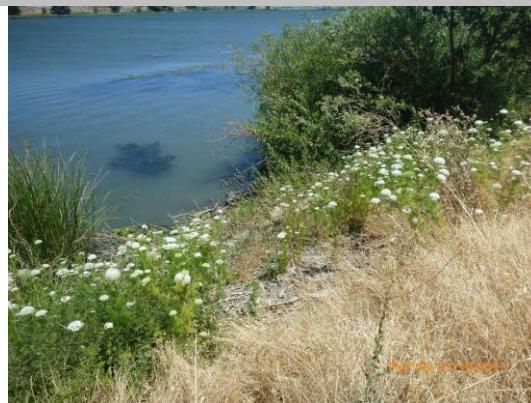
LM Start	2.02	Rating **	M	Issue No.	26 (cont)
LM End	2.06	Issue Type +	Ma	Location *	
Category	Supplemental			GPS Latitude/Longitude	
				Start	End
Item	2017 Storm Damage			38.283914 °	38.283422 °
				-121.718614 °	-121.718206 °
DWR ID	DWR_RD2060_03_f_2017_26				
Comment Code					
Inspector Comment					
Levee Evaluation Comments Description: Erosion commences halfway down the slope and results in slippage into the waterside toe. Existing rip rap has sloughed into the water side toe. Site ID No: 396 Site Designation: LMA-223 Repair Type: Erosion Rating: Area of Concern Field Date: 7/18/2017 Notes: Erosion to high water line.

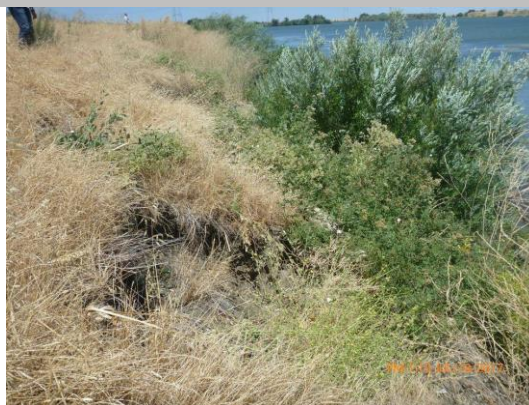
Photo 1 of 3 : SP_2018_RD2060_243_27_20180305_00043.jpg

LM Start	2.12	Rating **	A/W	Issue No.	27
LM End	2.15	Issue Type +	Ma	Location *	
Category	Supplemental			GPS Latitude/Longitude	
				Start	End
Item	2017 Storm Damage			38.282733 °	38.282403 °
				-121.717683 °	-121.717428 °
DWR ID	DWR_RD2060_03_f_2017_27				
Comment Code					
Inspector Comment					
Levee Evaluation Comments Description: Erosion commences approximately 1/4 of the way down the slope and results in slippage into the waterside toe. Site ID No: 397 Site Designation: LMA-224 Repair Type: Erosion Rating: Serious Field Date: 7/18/2017 Notes: Benched erosion with large cracks on slope above. Light veg in erosion.

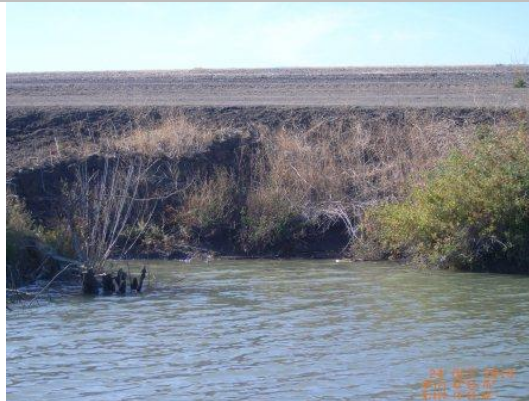
Photo 1 of 1 : SP_2018_RD2060_243_7_20180305_00007.jpg

LM Start	2.18	Rating **	A/W	Issue No.	7
LM End	2.23	Issue Type +	Ma	Location *	WS
Category	Supplemental			GPS Latitude/Longitude	
				Start	End
Item	2015 USACE Erosion Survey, DRAFT			38.282100 °	38.281510 °
				-121.716817 °	-121.716319 °
DWR ID	DWR_RD2060_03_s_2016_7				
Comment Code					
Inspector Comment					
2007 - Geotechnical failure of midside slope and wave wash/scalloping in toe area. Stone revetment upstream and downstream of site. Similar sites are present all along the right bank downstream of this site, most could be repaired with some maintenance. 2010 - Minor new erosion. 2015: No observed changes. [2015 Site ID: CHS_22-8_R]

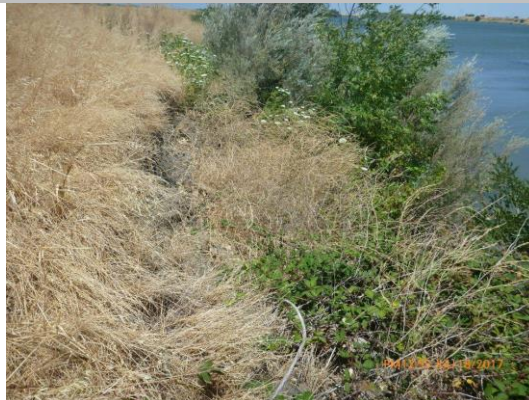
Photo 1 of 3 : SP_2018_RD2060_243_28_20180305_00046.jpg

LM Start	2.19	Rating **	A/W	Issue No.	28
LM End	2.22	Issue Type +	Ma	Location *	
Category	Supplemental			GPS Latitude/Longitude	
				Start	End
Item	2017 Storm Damage			38.281839 °	38.281486 °
				-121.716964 °	-121.716661 °
DWR ID	DWR_RD2060_03_f_2017_28				
Comment Code					
Inspector Comment					
Levee Evaluation Comments Description:Erosion commences approximately 1/4 of the way down the slope and results in slippage into the waterside toe. Site ID No:398 Site Designation:LMA-225 Repair Type: Erosion Rating:Serious Field Date:7/18/2017 Notes: Erosion is near vertical with light veg. Existing rip rap to the left of site.

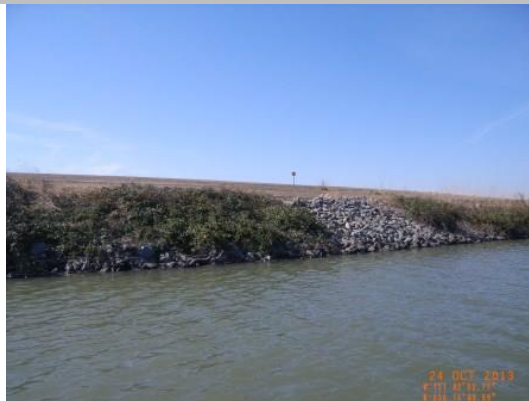
Photo 1 of 1 : SP_2018_RD2060_243_4_20180305_00004.jpg

LM Start	2.35	Rating **	A/W	Issue No.	4
LM End	2.53	Issue Type +	Ma	Location *	WS
Category	Supplemental			GPS Latitude/Longitude	
				Start	End
Item	2015 USACE Erosion Survey, DRAFT			38.280377 °	38.278306 °
				-121.714633 °	-121.712722 °
DWR ID	DWR_RD2060_03_s_2016_4				
Comment Code					
Inspector Comment					
2008 - Small scour pockets and mid-slope wave wash. 2010 - More vegetation growth, could be fixed through maintenance. 2011 - Site extended downstream and new erosion. 2015: No observed changes. [2015 Site ID: CHS_22-6_R]

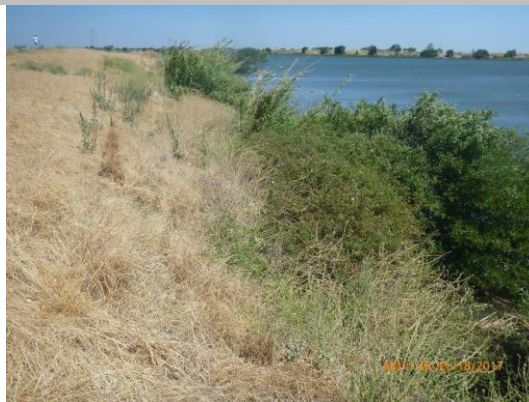
Photo 1 of 3 : SP_2018_RD2060_243_31_20180305_00052.jpg

LM Start	2.36	Rating **	M	Issue No.	31
LM End	2.43	Issue Type +	Ma	Location *	
Category	Supplemental			GPS Latitude/Longitude	
				Start	End
Item	2017 Storm Damage			38.280208 °	38.279336 °
				-121.714853 °	-121.714172 °
DWR ID	DWR_RD2060_03_f _ 2017_31				
Comment Code					
Inspector Comment					
Levee Evaluation Comments					
Description:Erosion commences approximately halfway down the slope and results in slippage into the waterside toe.					
Site ID No:400					
Site Designation:LMA-227					
Repair Type: Erosion					
Rating:Area of Concern					
Field Date:7/18/2017					
Notes: Steep cut but protected with heavy woody veg.

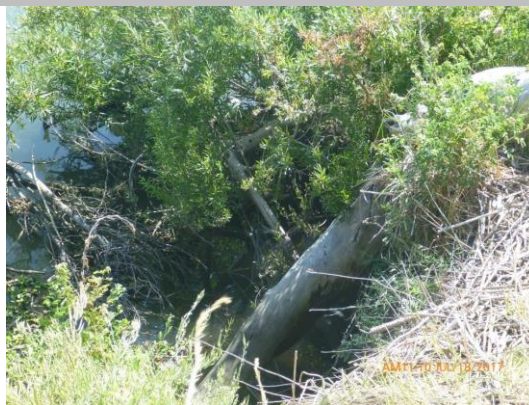
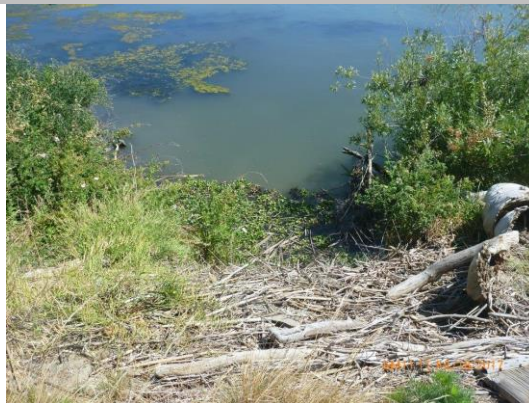
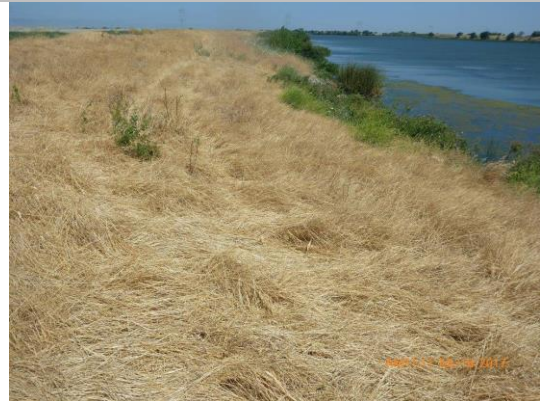
LM Start	2.55	Rating **	M	Issue No.	33
LM End	2.55	Issue Type +	Ma	Location *	
Category	Supplemental			GPS Latitude/Longitude	
				Start	End
Item	2017 Storm Damage			38.277956 °	38.277928 °
				-121.712814 °	-121.712775 °
DWR ID	DWR_RD2060_03_f _ 2017_33				
Comment Code					
Inspector Comment					
Levee Evaluation Comments					
Description:Erosion commences approximately halfway down the slope and extends to the waterside toe.					
Site ID No:402					
Site Designation:LMA-229					
Repair Type: Erosion					
Rating:Area of Concern					
Field Date:7/18/2017					
Notes: Small but deep vertical cut down to water.

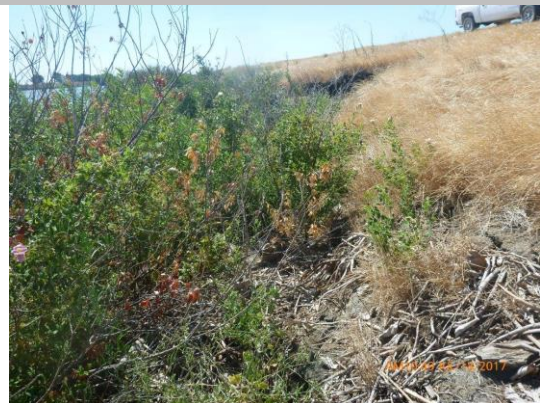
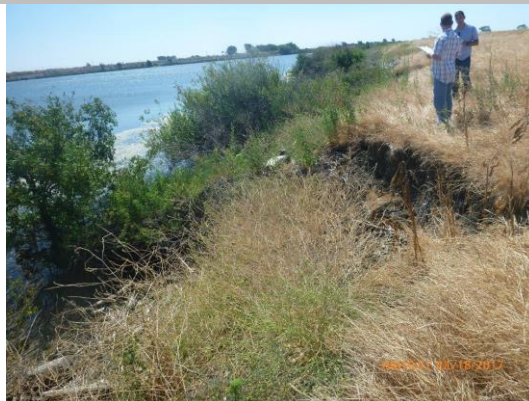
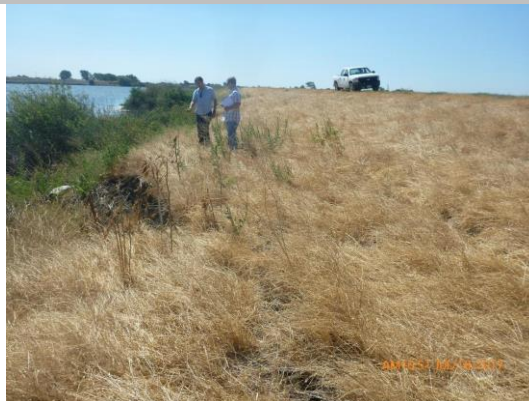
Notes: Erosion causing sloughing. Horizontal cracks about 6' up from erosion.

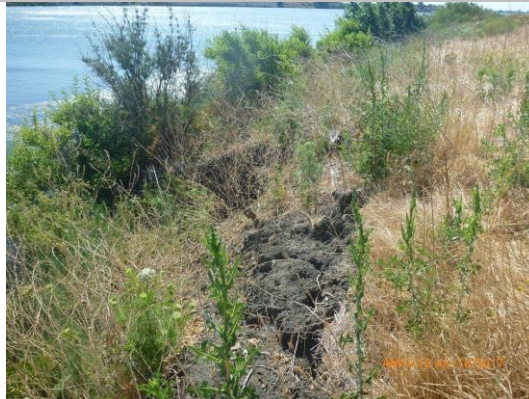
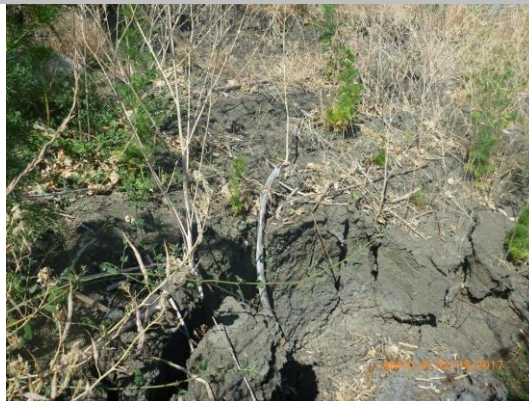
LM Start	2.64	Rating **	M	Issue No.	35
LM End	2.64	Issue Type +	Ma	Location *	
Category	Supplemental			GPS Latitude/Longitude	
				Start	End
Item	2017 Storm Damage			38.277106°	38.277078°
				-121.711489°	-121.711447°
DWR ID	DWR_RD2060_03_f _ 2017_35				
Comment Code					
Inspector Comment					
Levee Evaluation Comments					
Description:Erosion commences approximately 1/4 of the way down the slope and results in sloughing into the waterside toe.					
Site ID No:404					
Site Designation:LMA-231					
Repair Type: Erosion					
Rating:Area of Concern					
Field Date:7/18/2017					
Notes: Small erosion and sloughing adjacent to revetted slope.

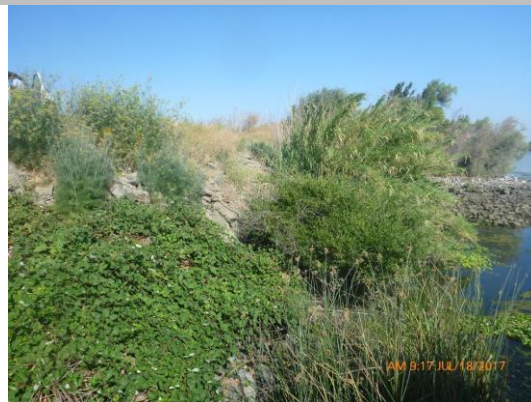
Photo 1 of 3 : SP_2018_RD2060_243_37_20180305_00070.jpg

LM Start	3.24	Rating **	M	Issue No.	37
LM End	3.24	Issue Type +	Ma	Location *	
Category	Supplemental			GPS Latitude/Longitude	
				Start	End
Item	2017 Storm Damage			38.270231 °	38.270203 °
				-121.705897 °	-121.705856 °
DWR ID	DWR_RD2060_03_f_2017_37				
Comment Code					
Inspector Comment					
Levee Evaluation Comments					
Description:Erosion commences approximately halfway down the slope and results in sloughing into the waterside toe. Existing rip rap has been pulled off the slope at this site.					
Site ID No:406					
Site Designation:LMA-233					
Repair Type: Erosion					
Rating:Area of Concern					
Field Date:7/18/2017					
Notes: Erosion is next to a pumphouse and slope is protected withrip rap.

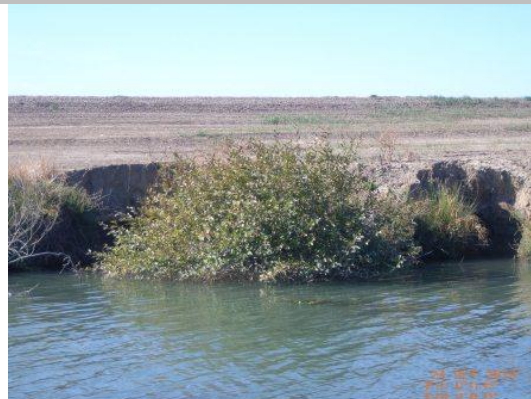
Photo 1 of 1 : SP_2018_RD2060_243_2_20180305_00002.jpg

LM Start	3.78	Rating **	A/W	Issue No.	2
LM End	4.09	Issue Type +	Ma	Location *	WS
Category	Supplemental			GPS Latitude/Longitude	
				Start	End
Item	2015 USACE Erosion Survey, DRAFT			38.264585 °	38.260593 °
				-121.698868 °	-121.696403 °
DWR ID	DWR_RD2060_03_s_2016_2				
Comment Code					
Inspector Comment					
2011 - Several pockets of erosion from rotational failure and slumping toe. 2013 - Site extended downstream to include new erosion pockets. 2015: No observed changes. [2015 Site ID: CHS_21-1_R]

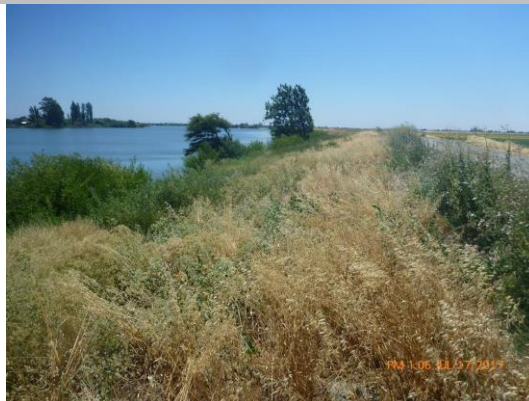
Photo 3 of 3 : SP_2018_RD2060_243_40_20180305_00078.jpg

LM Start	3.82	Rating **	A/W	Issue No.	40 (cont)
LM End	3.94	Issue Type +	Ma	Location *	
Category	Supplemental		GPS Latitude/Longitude		
			Start	End	
Item	2017 Storm Damage		38.264006 °	38.262364 °	
			-121.698811 °	-121.698103 °	
DWR ID	DWR_RD2060_03_f_2017_40

Comment Code					
Inspector Comment					
<p>Levee Evaluation Comments</p> <p>Description: Erosion commences approximately halfway down the slope and results in sloughing into the waterside toe. Existing rip rap has been pulled off the slope at this site</p> <p>Site ID No: 410</p> <p>Site Designation: LMA-237</p> <p>Repair Type: Erosion</p> <p>Rating: Serious</p> <p>Field Date: 7/18/2017</p> <p>Notes: This site is combined with LMA-234. There is minor toe erosion along whole 631 lf, but there is a 20' wide deep erosion at 38.26347, -121.69859. That is the only location that is serious and is likely due to a collapsed beaver den.</p>
